Manhole Inspection Summary

Manhole # S39A__034MH

Insp Date: **11/19/08 10:27 AM**

Location Address: **510 ensor st**

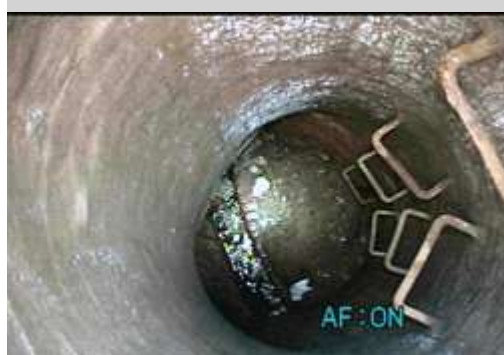
Top View

cant see 12 from top

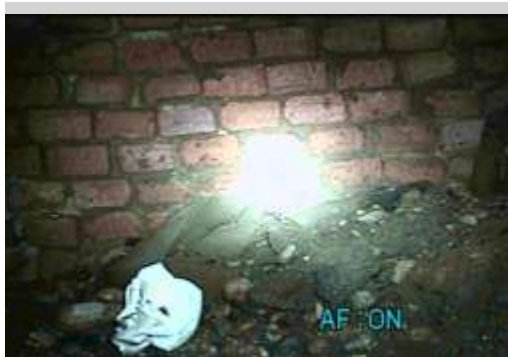
Defect 4

Condition: ☐ Sound ☐ Cracked ☐ Root Intrusion ☐ Deteriorated ☐ Leaks ☒ **Debris**

bench debris

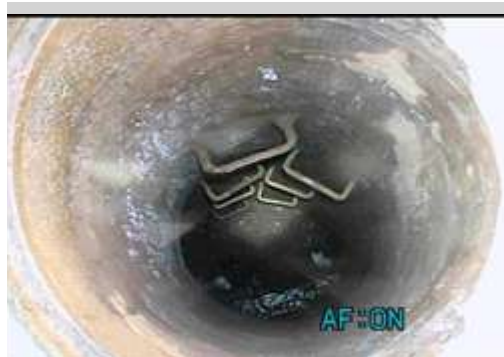
Defect 3

☒ **Leaks**

Count: **7** Missing: **0** ☒ **Corroded**

frame leaks, corr steps

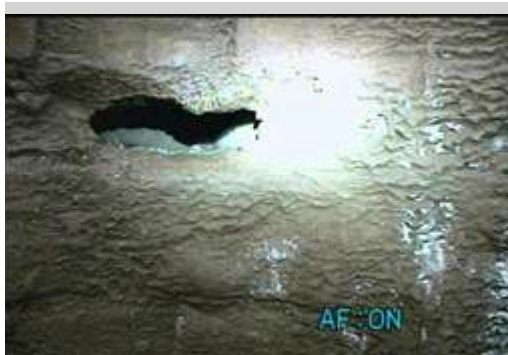
Defect 2

hole in corbel

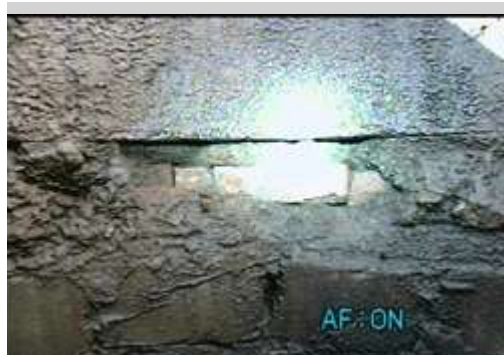
Defect 1

Condition: ☐ Sound ☐ Cracked ☐ Root Intrusion ☒ **Loose Brick** ☒ **Deteriorated**

Infiltration: ☐ None ☐ Joint ☐ Cracks ☐ Mortar ☐ Roots ☒ **Wall**

deteriorated corbel, infiltration, frame adj

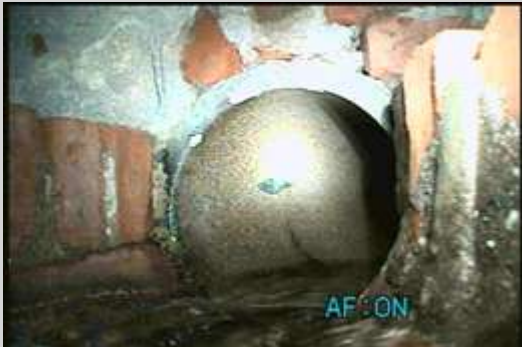
12 O'Clock Outflow

best shot do to angle
